# A SEM Study Of Copper Corrosion In Bowling Green Supply Lines

A SEM STUDY OF COPPER CORROSION IN BOWLING GREEN SUPPLY LINES

A Thesis  
Presented to  
The Faculty of the Department of Chemistry  
Western Kentucky University  
Bowling Green, Kentucky

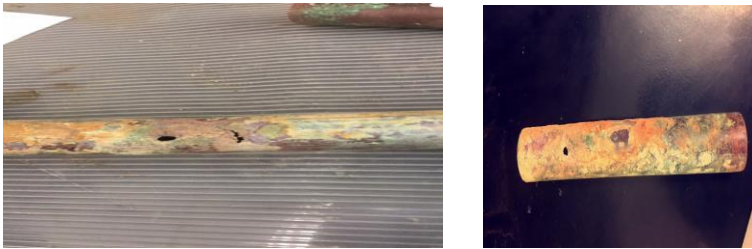
Recently, corrosion of water pipes in Bowling Green, Kentucky has sharply increased. While age was the most common factor initially considered, most of these recent breaks have been in copper pipes less than 20 years old. Moreover, these pipes have corroded from the outside, rather than the inside. These breaks have occurred in copper pipes within a few feet of a curb, under the roadway, leading to speculation as to the factors leading to the breaks, such as the bedding materials (limestone rocks and the constant vibrations from the roadway from the movement of traffic. Figure 4 shows the pipes were corroded from the outside. The original pipe retained most of its thickness and native material.

Figure 4: Corroded water pipe sample from Bowling Green, KY

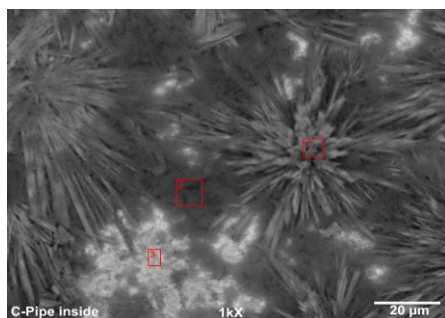
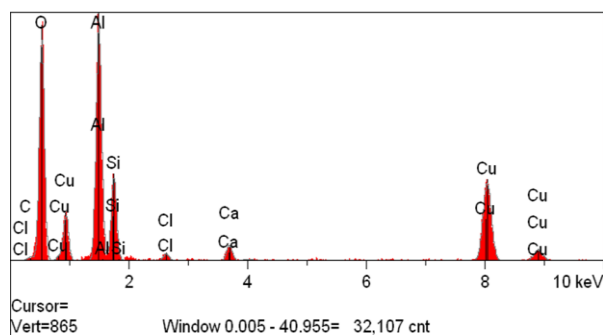
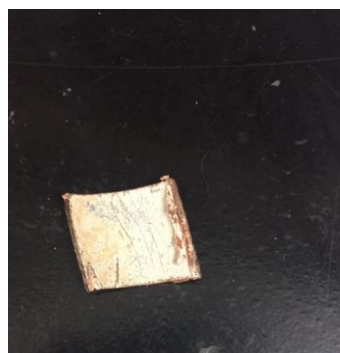
Figure 9 shows the SEM images of the inside area of corroded pipe C. The SEM images show flower-like growths which appear on the surface. Compositions were analyzed for three areas. Spot 1 is on the flower-like area, while spots 2 and 3 were taken on the smooth area. Spot 1 contains Cu (17.00%), Al (13.54%), Si (4.40%), Ca (0.55%) and O (64.51%). Spot 2, which is darker than spot 3, contains Cu (10.72%), Al (19.06%), Si (6.53%), Ca (0.67%), Cl (0.35%) and O (62.67%). Spot 3 contains Cu (27.57%), C (7.93%), O (48.34%), Si (3.87%) and Al (12.29%). From the data shown above, it is most likely that the flower-like material is CuO while spot 2 is where CuO is just starting to grow. Figure 10 is from the outside of corroded pipe C and shows the presence of copper minerals such as malachite and azurite or to other common minerals such as goethite, and calcite.

Figure 10: SEM image and analysis of the inside of pipe C

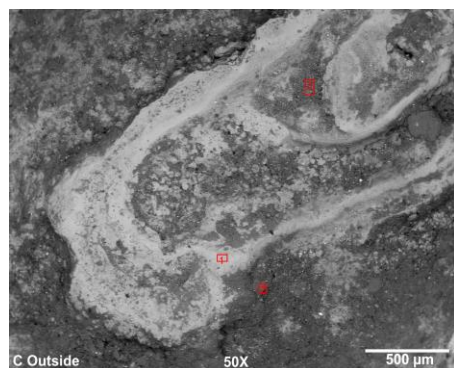
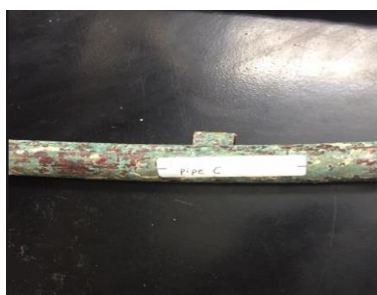
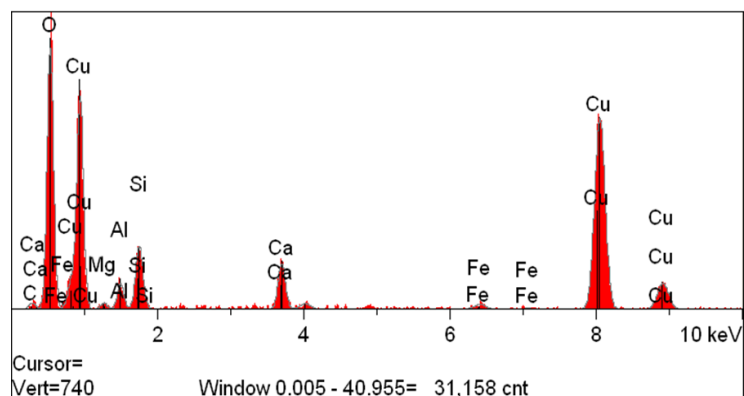
Figure 11: SEM image and analysis of the outside of pipe C

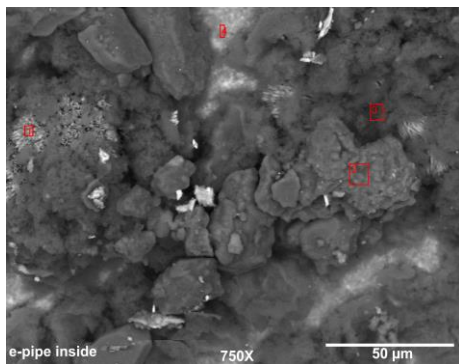
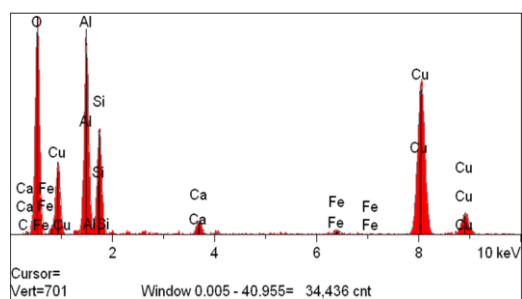
Figure 11 shows a SEM image of the inside area of corroded pipe E. From the SEM image of the inside area, data were taken on four spots. Spot 1 is on the area with a lot of needle-like material. Spot 2 is the place with more small particles. Spot 3 is the darkest area, while spot 4 is the brightest. Spot 1 data are Cu (18.60%), Al (15.61%), Si (7.61%), Ca (0.62%), C (1.90%), Fe (0.29%) and O (55.33%). Spot 2 data are Cu (3.55%), Al (11.18%), Si (17.77%), Ca (0.37%), Fe (1.33%), Mg (0.61%), K (0.35%), Cl (0.09%) and O (65.04%). Spot 3 data are Cu (18.82%), O (50.79%), Al (18.36%), Si (10.88%), Ca (0.62%), Cl (0.16) and Fe (0.36) while Spot 4 showed Cu (15.35%), O (58.10%), Al (16.22%), Si (9.41%), Ca (0.62%) and Cl (0.30%). Spot 2 contains much more Si than the other areas, which means the small particles are likely SiO<sub>2</sub>. Spot 3 and Spot 4 are similar. From the SEM image of the outside area (Figure 12), there are not big blocks like what is shown on inside surface. Compared to the inside area, the outside one is much smoother with more small particles on the surface. In the smooth area, the analysis shows Cu (50.13%), O (43.48%), Al (1.23%), Si (3.07%) and Ca (2.09%), while the small particles contain Cu (19.53%), Al (1.20%), Si (3.76%), Ca (4.77%), Fe (0.29%), Mg (1.10%), K (0.11%), C (22.74%) and O (46.51%). In comparison to the uncorroded pipe outside area, there are more impurities in the small particles on the surface and the amount of C is also larger.

Figure 12: SEM image and analysis of the inside of pipe E inside

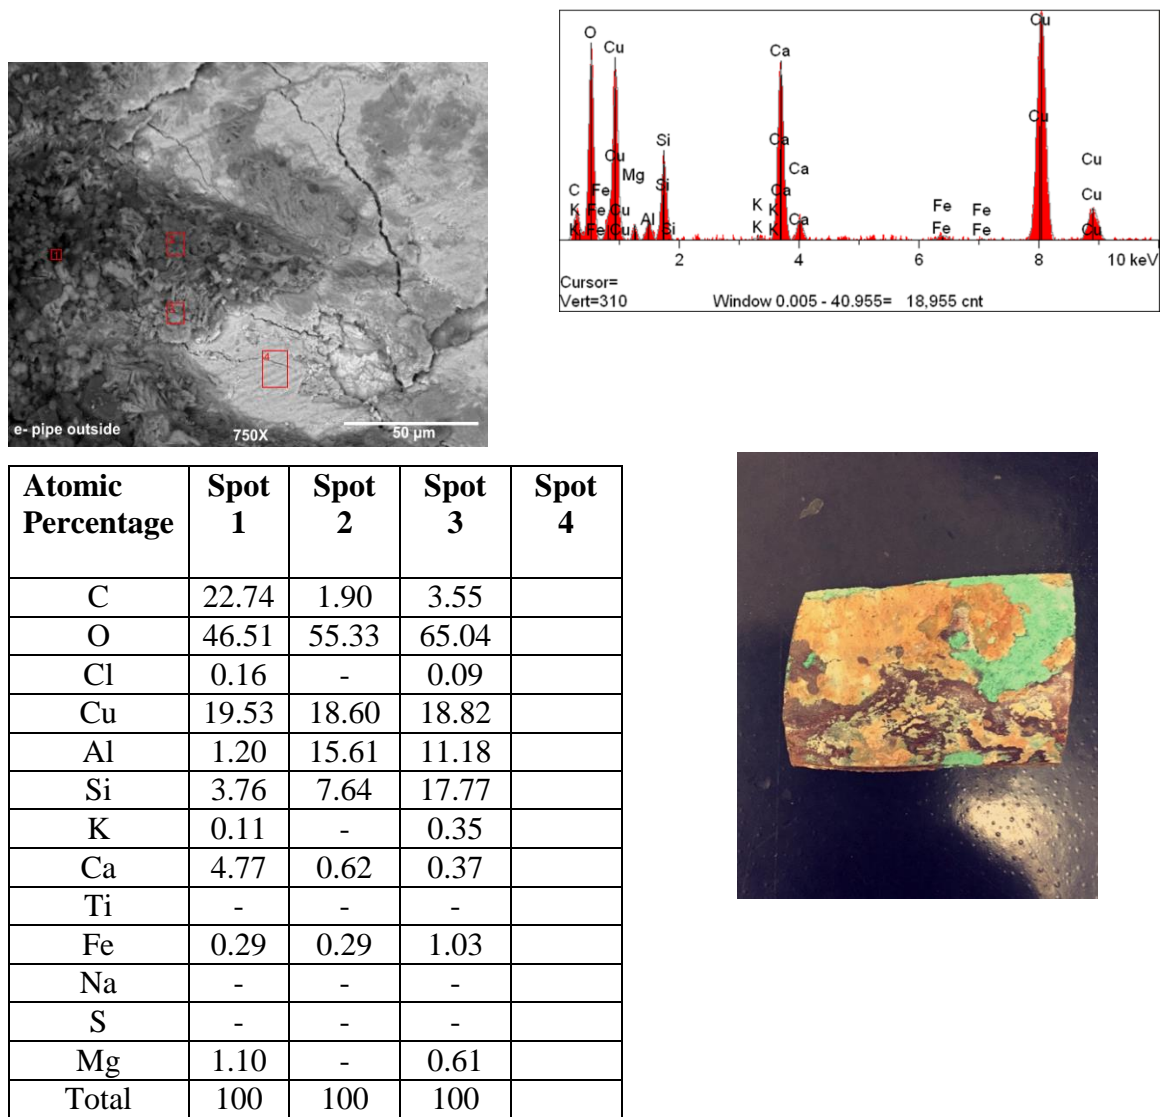
Figure 13: SEM image and analysis of pipe E outside

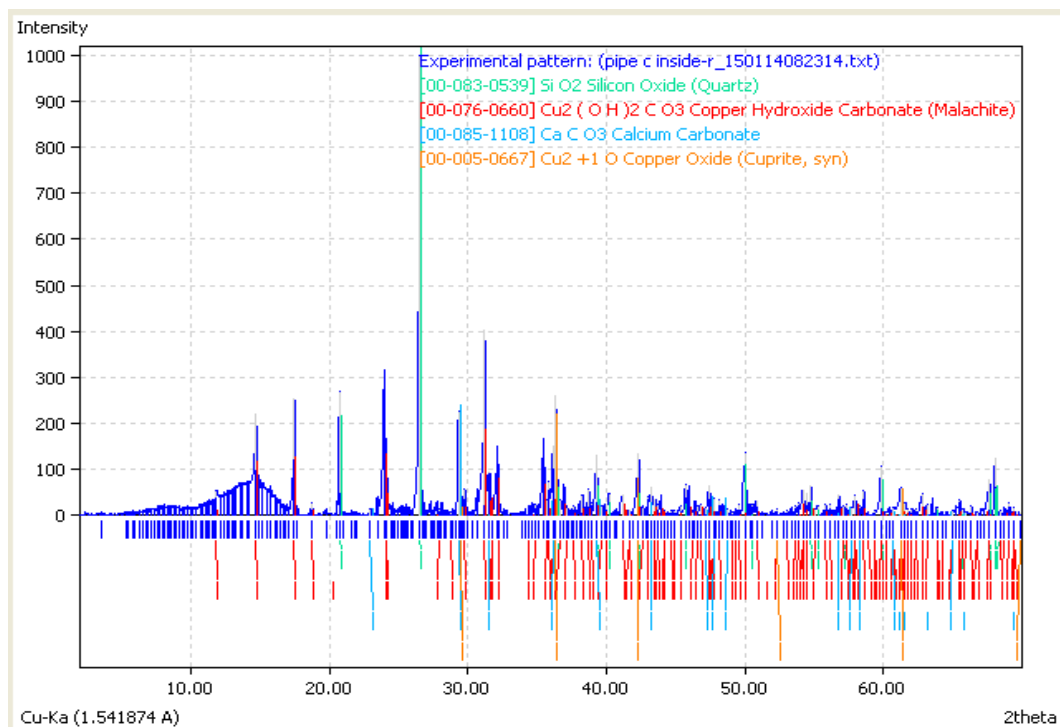
X-ray diffraction measurements were taken to determine what minerals were on pipe C's inside and outside surface. By matching the testing results to a data bank, the inside surface of the pipe contained silicon dioxide ( $\text{SiO}_2$ , Quartz), copper hydroxide carbonate ( $\text{Cu}_2(\text{OH})_2\text{CO}_3$ , Malachite), calcium carbonate ( $\text{CaCO}_3$ ) and copper oxide ( $\text{Cu}_{2+1}\text{O}$ , Cuprite, syn). The outside surface contains copper hydroxide carbonate ( $\text{Cu}_2(\text{OH})_2\text{CO}_3$ , Malachite), iron aluminum oxide ( $\text{Fe}_2\text{Al}_2\text{O}_4$ , Hercynite, syn), calcium carbonate ( $\text{CaCO}_3$ , Calcite, syn), silicon oxide ( $\text{SiO}_2$ , quartz low) and copper oxide ( $\text{Cu}_2\text{O}$ , Cuprite).

Figure14: XRD spectra of the powder inside of C copper pipe.

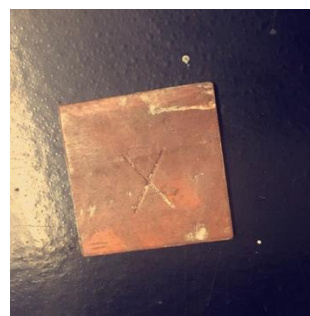
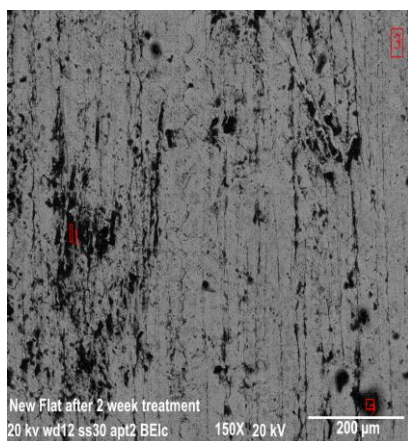
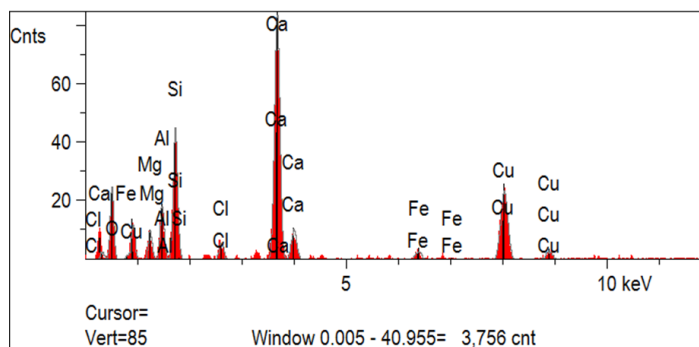
Figure 15 shows the SEM image of uncorroded pipe with pipe in contact with water, limestone and vibrations was compared after two weeks of vibrations. After two weeks, the pipe showed longer sections of dark spots forming line-like structures. This could be due to the scraping of limestone on the pipe under the conditions of shaking.

The SEM analysis showed the percentage of calcium on the surface as did oxygen, showing that calcium carbonate is depositing on the surface. A trace amount of iron deposits were also detected. The iron can be from either the water or limestone.

Figure 16: SEM image and analysis of new pipe and limestone after two weeks

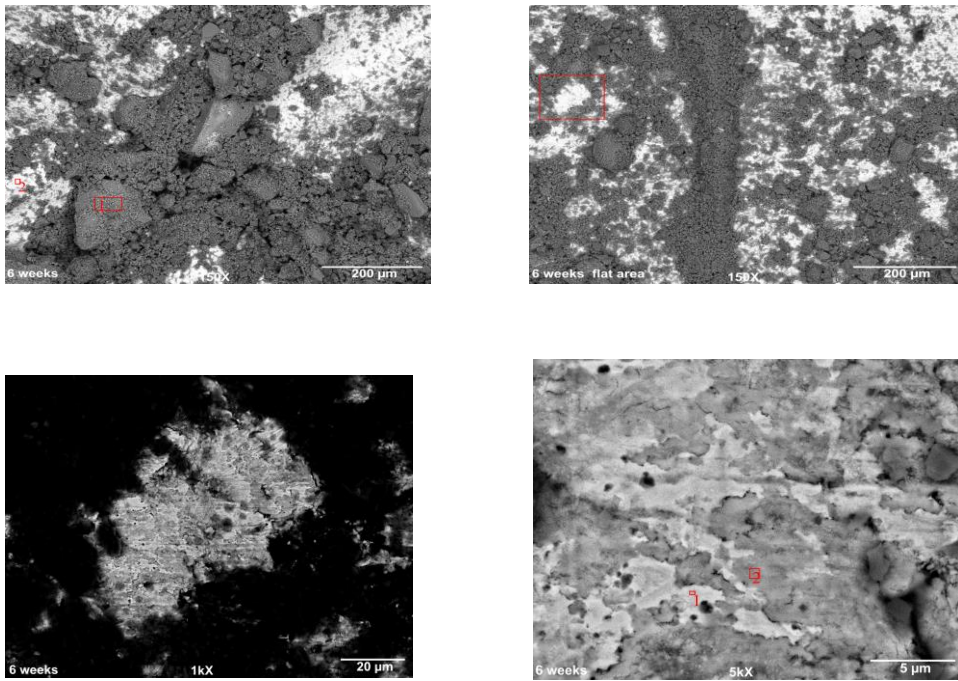
Figure 18 shows the SEM image of flat copper pipes with water, limestone, and vibration after 6 weeks. The SEM images show many more impurities, which contains calcium and oxygen and are probably calcium carbonate deposits from the limestone. Moreover, expanded views of the surface shows substantial pitting, growths of calcium carbonate filling in the pits and growing together. The 5K image show a lot of pitting on the surface because limestone causes damage on the surface.

Figure 19: SEM image of flat copper pipes with water, limestone, and vibration after 6 weeks.

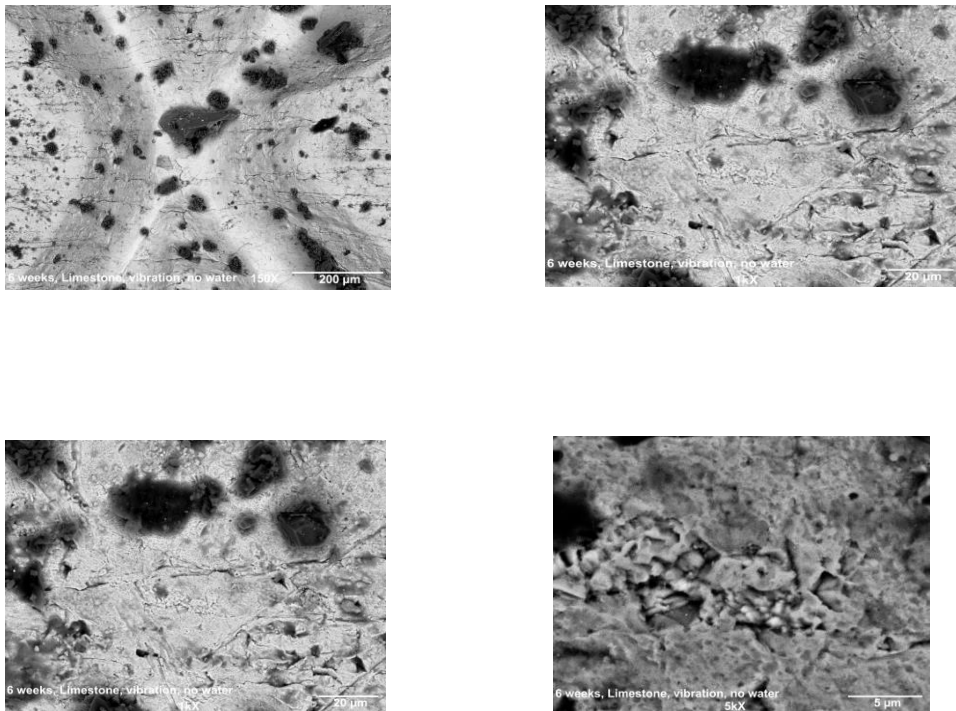
The effect of water is clear. Figure 19 shows SEM image of flat copper pipes with limestone, vibration, and no water after 6 weeks. Little pitting is observed. The X scratch is clean and clear. The dark areas are calcium carbonate but this appears to be mostly dust that settled onto the surface and grooves.

Figure 20: SEM image of flat copper pipe with limestone, vibration, and no water after 6 weeks.

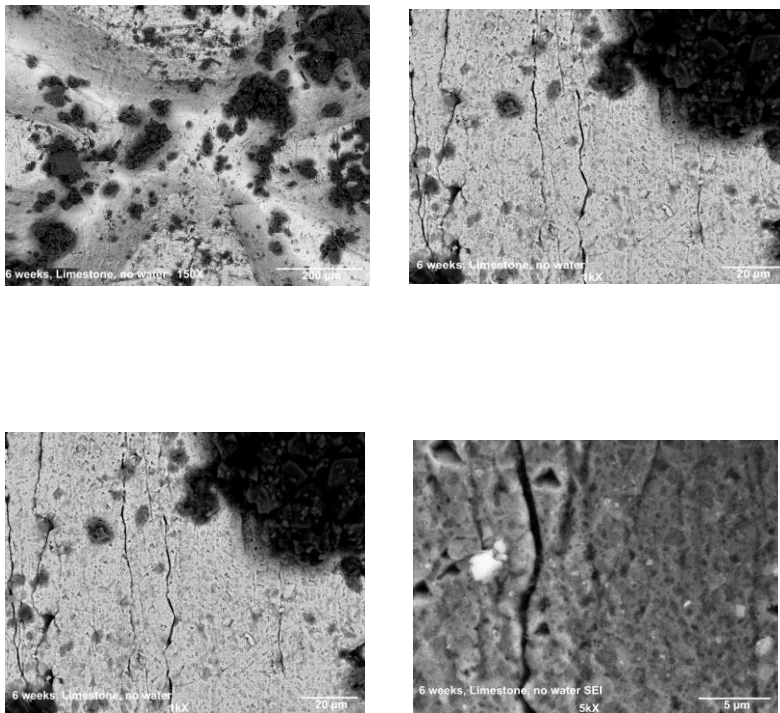
Figure 20 shows the SEM image of flat copper pipe with limestone but with no water and no vibration. From SEM image of X scratches and flat area, we can find it has only slight impurities. The dark areas are calcium carbonate. This sample indicated what dust from the limestone on the surface would be, although even dust creates a slightly impacted surface

Figure 21: SEM image of flat copper pipe with limestone, no vibration, and no water after 6 weeks.

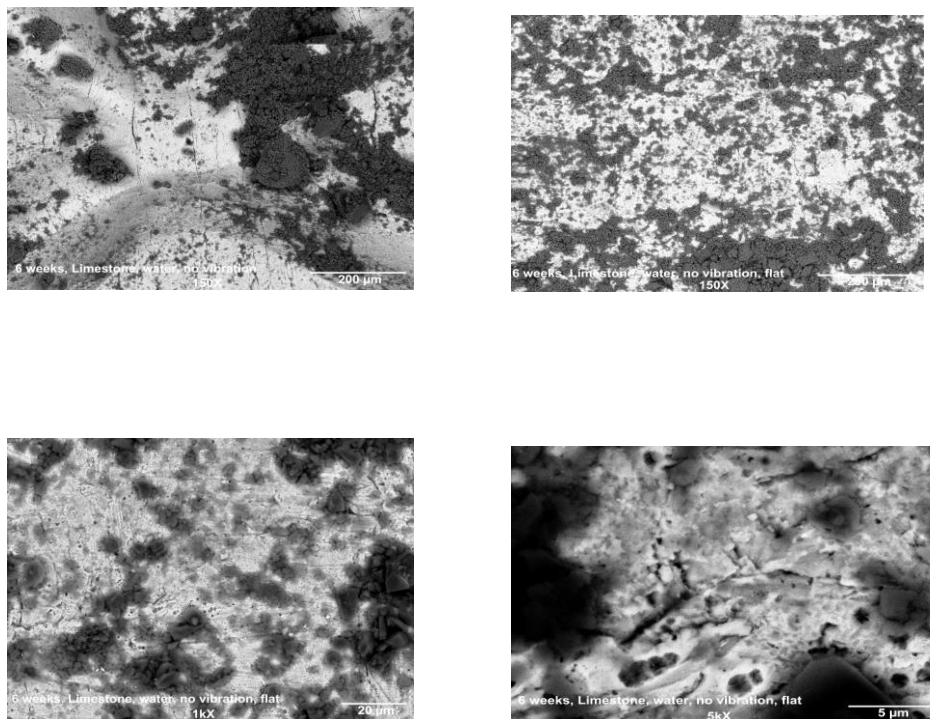
Figure 21 shows SEM image of flat copper pipe with limestone and water but no vibration. From the image of the X scratch and the flat area, we see increased pitting and calcium carbonate deposits. Even without vibration, the presence of water allows surface reactions to take place with the limestone. However, the vibrational motion clearly sharply enhances the deposition of calcium carbonate and changes in surface morphology.

Figure 22: SEM image of flat copper pipe with limestone, water, and no vibration, after 6 weeks.
